# **Navajo Abandoned Uranium Mine**

## **Site Screen Report**

### **Flag No. 1 Mine AUM Site**

#### **Navajo AUM Northern Region**

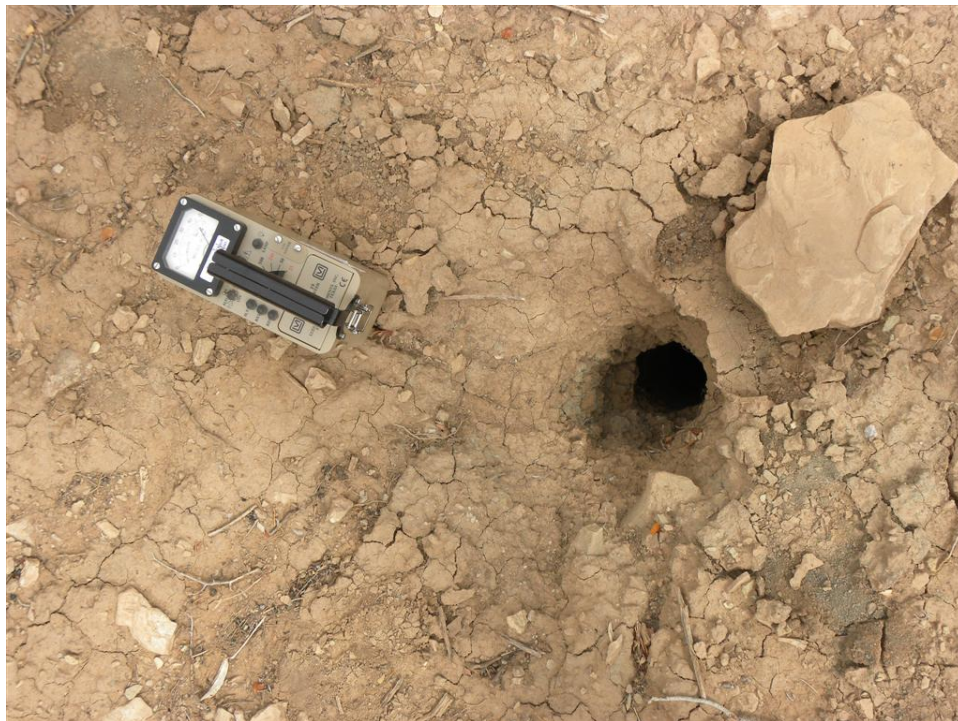
Some wood mining debris and ventilation holes

Photo 1. Ventilation hole

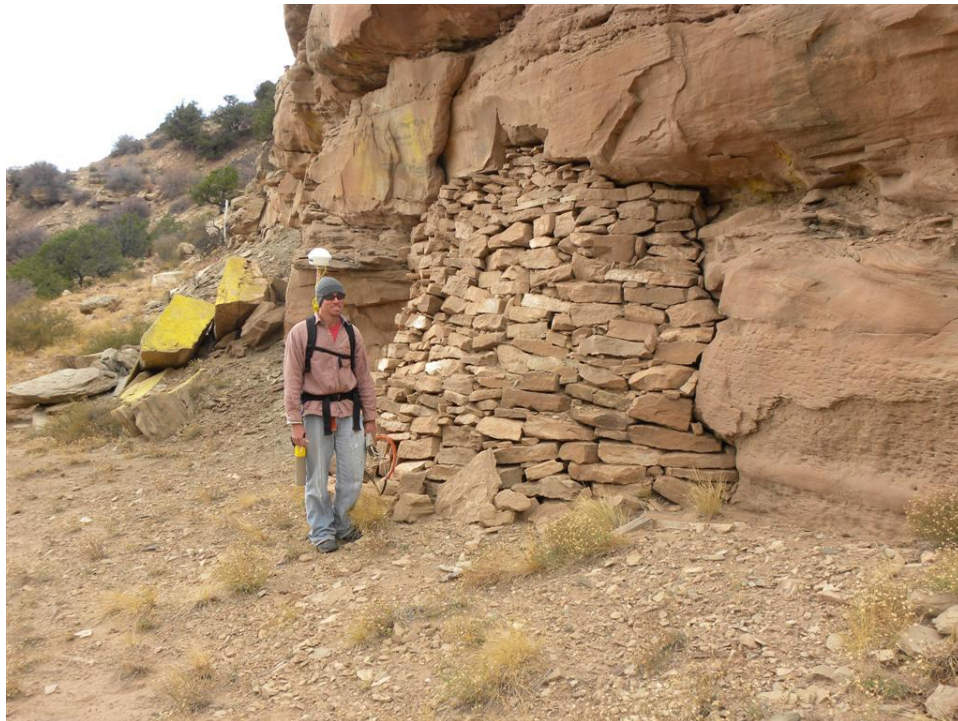
Stone sealed adit with painted yellow rocks

**Is the cap/seal functionally intact?** Yes

**Is the cap/seal sufficiently degraded to create a concern about releases?** No

Photo 2. Sealed adit and yellow painted rock

Sealed adit with yellow painted rock; mining debris, unreclaimed waste pile

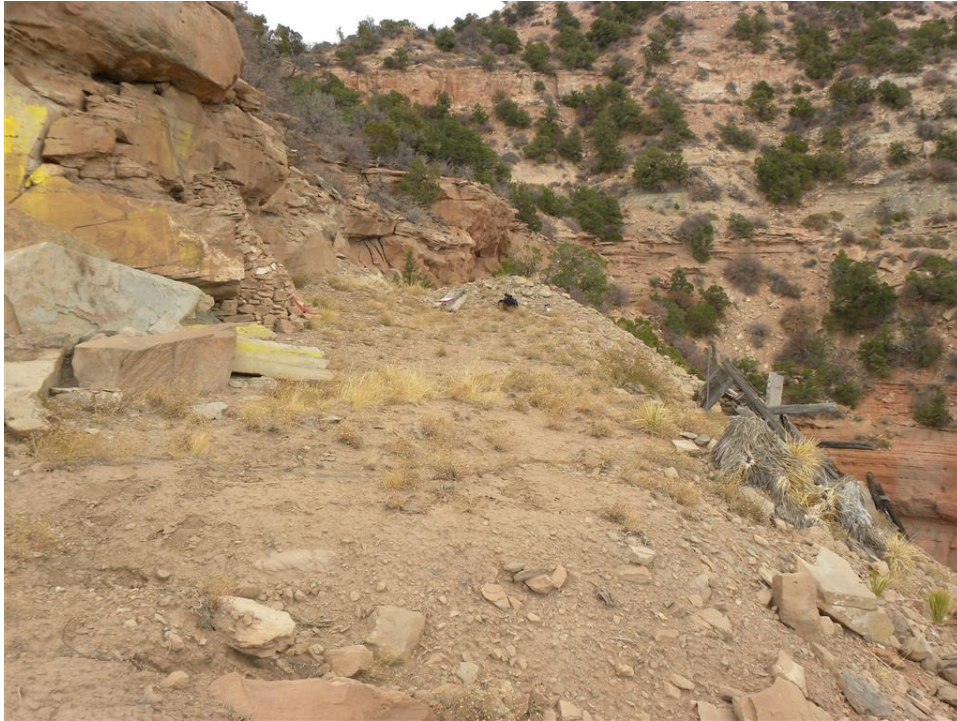
Waste pile stretches from end of haul road down slope (inaccessible) to upper edge of >100' sheer rock face, 100' x 100', with a total estimated volume of 1,852 yd<sup>3</sup>

Photo 3. Waste pile below adit

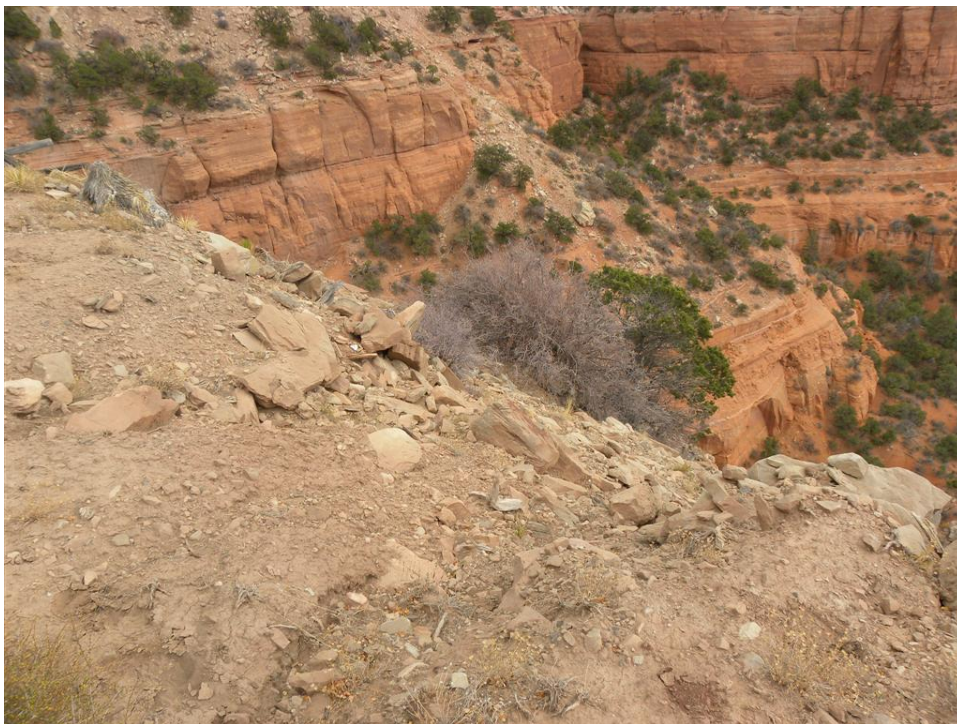
Photo 4. Waste pile

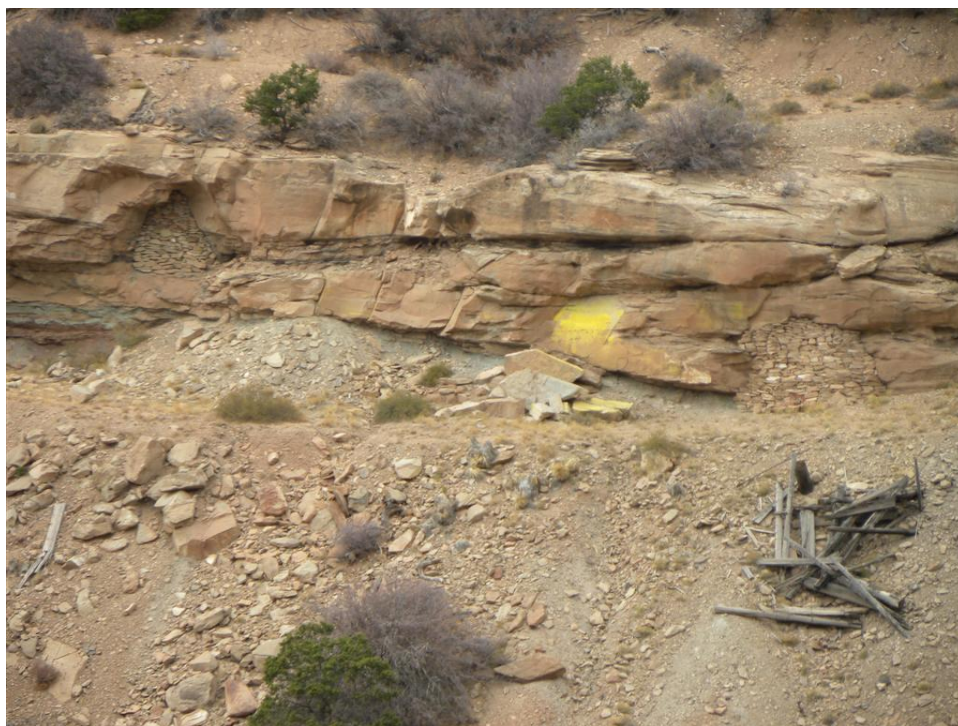
Photo 5. Sealed adit, wood mining debris, waste pile, and yellow painted rock
